COMPRESSION TESTS OF SIX CURVED PAPER-BASE PLASTIC

PANELS WITH OUTWARD-ACTING NORMAL PRESSURE

MEMORANDUM REPORT

Bureau of Aeronautics, Navy Department

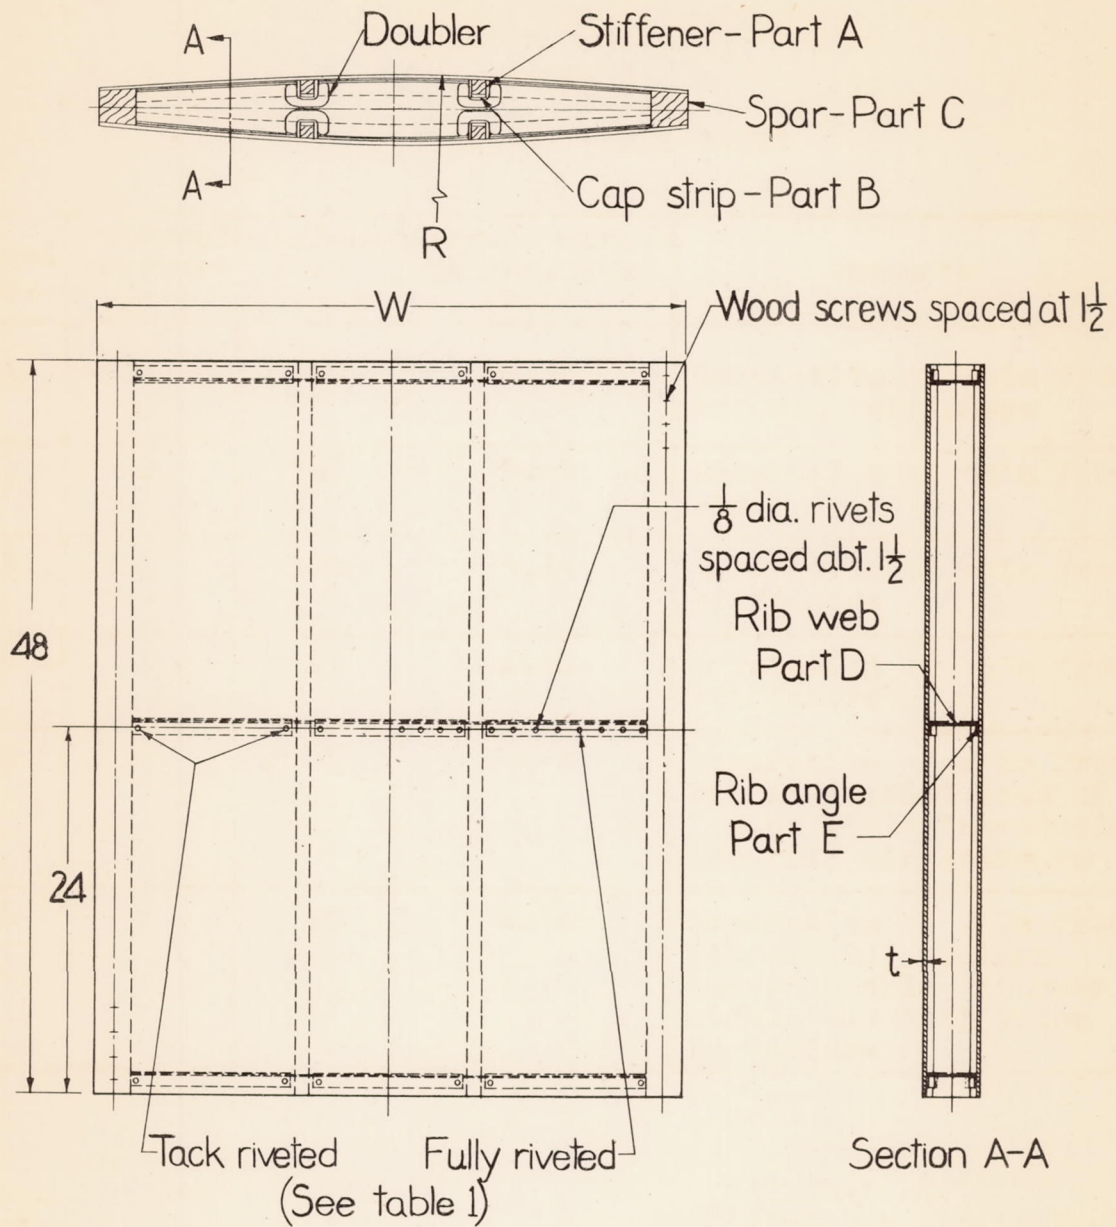
Figure 1.- Test panel.

Figure 1 illustrates the construction of the panels, and table 1 gives dimensions and other pertinent details.

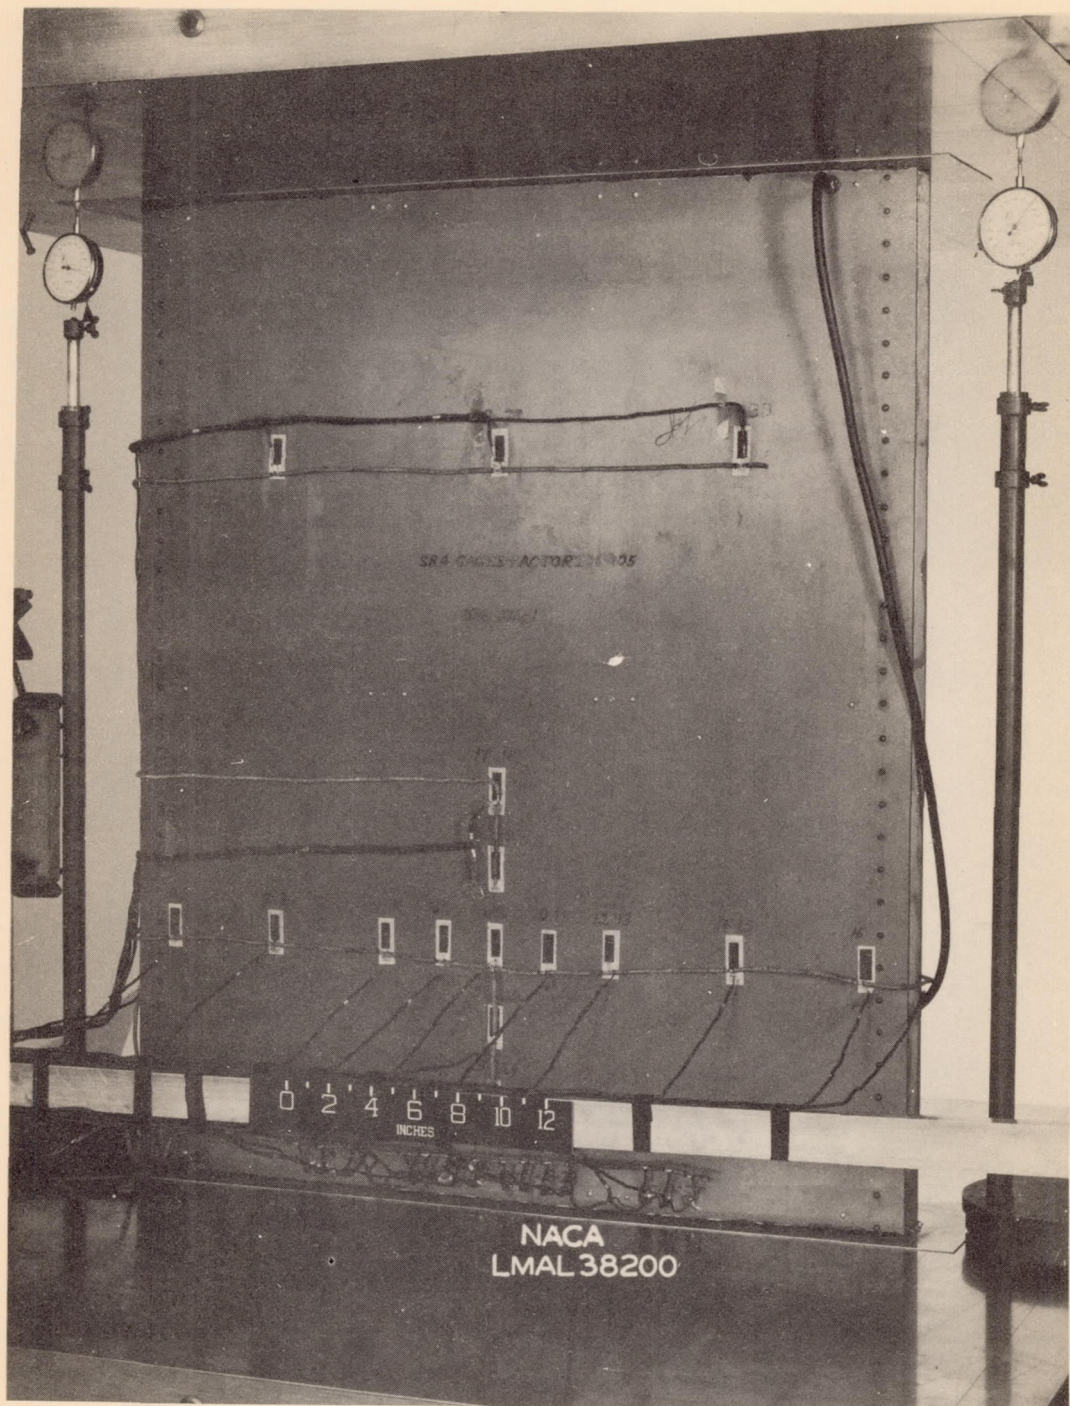
Figure 3.- Panel in testing machine.

A panel is shown in place in the testing machine in figure 3. The ends of the panels were ground flat and parallel to insure uniform distribution of load during the tests. A layer of Permatex was applied between the ends of the panels and the loading platens of the testing machine, so that internal air pressure could be maintained. A number of electrical strain gages were distributed over the inner and outer surfaces of each panel but, because of the nature of the failures that occurred, the data obtained from most of these gages were of little value.
